MARINE SURVEY REPORT

REPORT NUMBER: 20170503-12

TYPE OF SURVEY: Pre-purchase report/ Condition & Valuation

MAKE & MODEL: Intrepid Walk-Around 339

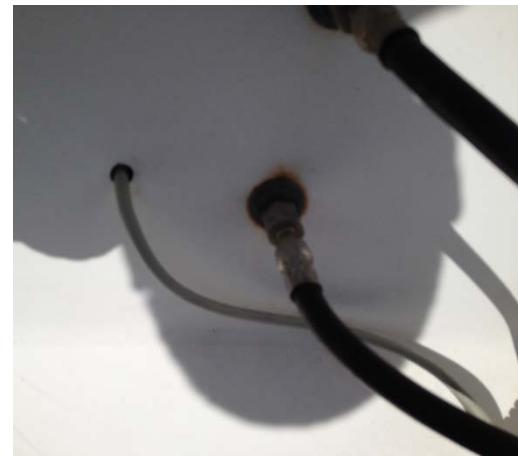
[SEE COMMENT \(1\).](#)

TRANSOM: The transom shows varying degrees of moisture. At the junction points with either side of the hull, levels are in the Moist range although percussive soundings show structural solidity. Area around engine mounts shows moisture levels in the Moist range but no cracks. Several hull penetrations are either unbedded or not sealed at all, as shown with the engine hydraulic cables and the rudder angle indicator wire.

1. Re-bed hydraulic cables' penetration point, replace rusted washers/plates and seal any open holes.
5. Repair/replace water damaged light fixtures to increase safety at sea at night.
10. Replace fuel cartridges and recycle gasoline in tank if possible or use a cleaning additive/enhancer.
12. Use of a larger or different style of anchor will provide safer anchoring given the specific nature of bottoms found in South Florida.
13. A longer length of chain of suitable marine grade metal as well as longer rode will allow for safer anchoring, especially in challenging conditions.
17. Install closed battery trays designed to contain lead acid spills.

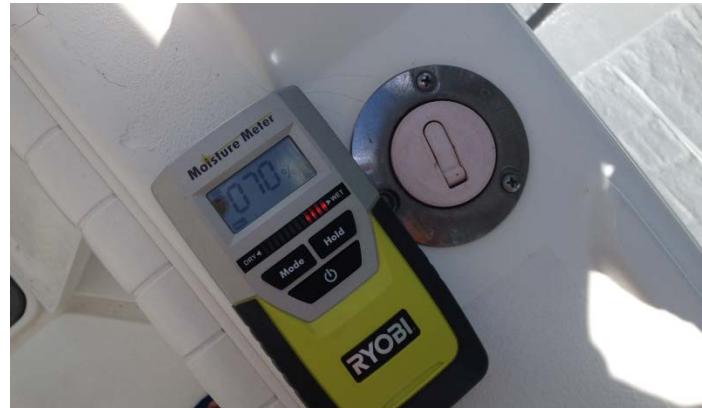
[SEE COMMENT \(4\).](#)

Molded FRP settee between cabin and command post. Detachable bench at the back was not secured to deck but holes for this purpose were visible. There are six rod holders embedded into the gunwale upper deck lips, none of which are properly bedded. This situation is repeated with the two fuel inlets located amidships, one on each side. Consequently, moisture readings are on the High level around all these hull penetrations.

- 2.** Repaint bottom with suitable anti-fouling paint in appropriate thickness.
 - 4.** Re-bed all rod holders and other hull penetrations.
 - 6.** Re-bed platforms and re-boarding ladder attachment points.
 - 11.** Change windlass foot switches position to a horizontal surface so they can be accessed while standing up instead of seated.
 - 20.** Replace all batteries with new units.
 - 21.** Strip anodes of paint or replace with new units, make sure anode surface is clean and directly exposed to the water, without coatings.
 - 22.** All underwater connections and through hulls should be stripped of paint and present a clear, uncoated surface to the water.
- 29 & 30.** In the surveyor's opinion, existing bilge pumping capacity may prove inadequate for thus boat. Larger pumps should be used, of at least two to three times the volume of existing ones.

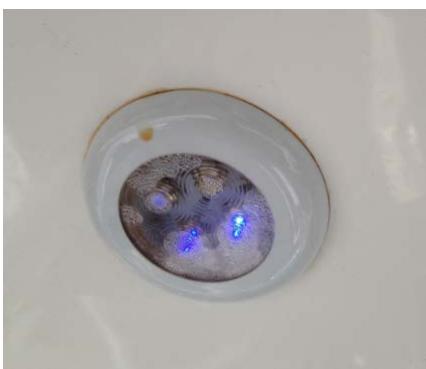
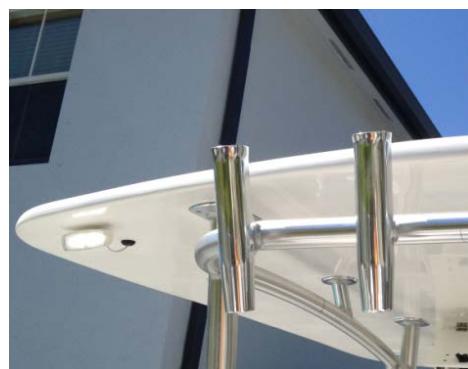
[SEE COMMENT \(5\).](#)

LIGHTING: There are six cockpit LED lights likely used as courtesy lights, four of them mounted on the hard top and two below the gunwales, one of each side amidships. Of the four lights on the hard top, three exhibit signs of water ingress/flooding and one has stopped working. There are also two flood/spreader LED lights mounted on the hard top which work, although the port side one also shows signs of water ingress.

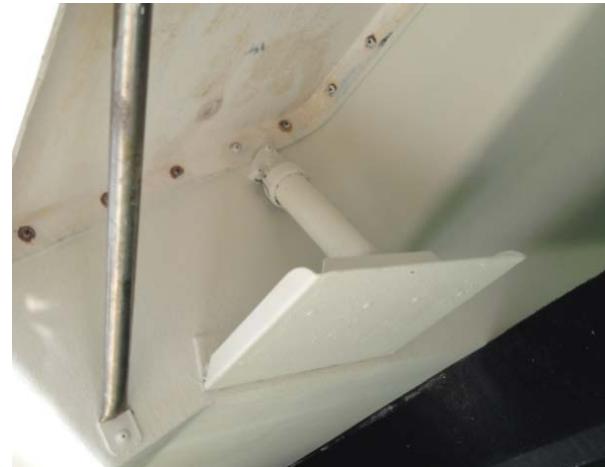
[SEE COMMENT \(6\).](#)

The stern is fitted with two attached swim/boarding platforms. Their attachment points are not properly bedded so moisture is penetrating into the hollowed stern/platform area. A pull-out re-boarding ladder under the port side also shows improperly bedded attachment.

TRIM TABS: Hydraulic trim tabs are in place and were heard to power up. However, neither tab moved in either direction, and both the tabs and cylinders were, again, not properly bedded onto hull. See above photo over "See Comment (6)".

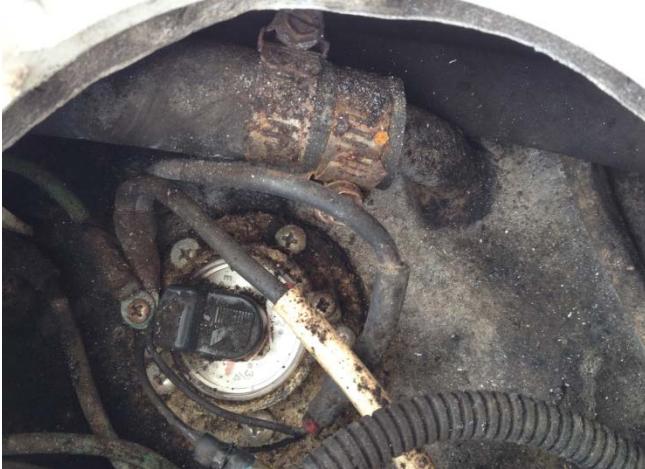
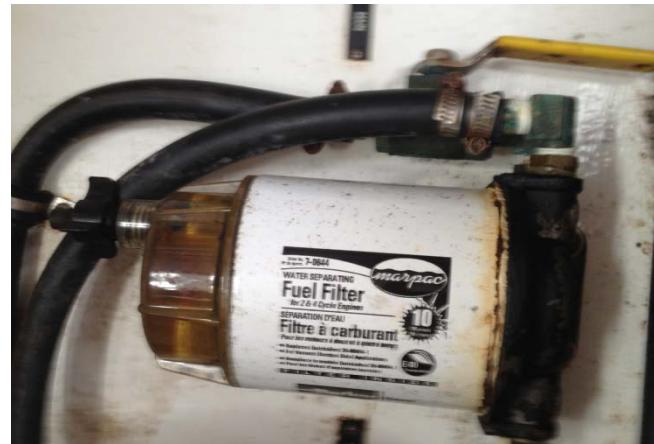
[SEE COMMENT \(9\).](#)

FUEL LINES(S): Fuel lines from the two side inlets into the single tank are of approved type and are suitably double clamped, however, the clamps are rusted and lose and under risk of coming undone, and the lines are extremely grimy and covered in sludge, presenting an unsafe situation. Likewise, fuel lines from the tank to the fuel filters/water separators feeding the engines are in better condition but are clamped with non stainless parts.

8. Repair tilt mechanism to make engine fully functional and enable twin engine maneuverability and dependability.
9. Properly clamp fuel lines with suitable stainless clamps to prevent possibility of line failure and fuel spillage.

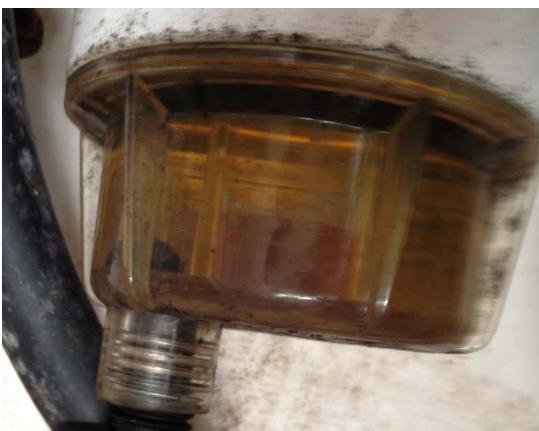
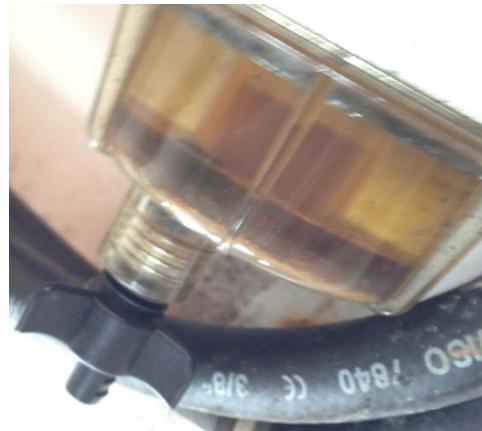
[SEE COMMENT \(10\).](#)

FUEL FILTERS: Racor type primaries with clear plastic bowls without heat shields are both mounted near the transom. Fuel in both filters is cloudy, too dark in coloration and both bowls contain some bacterial growth.

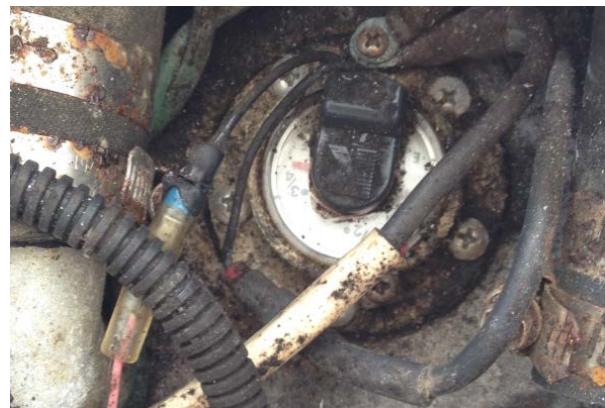
[SEE COMMENT \(18\).](#)

IGNITION PROTECTION: None required as fuel tank is contained away from motors BUT DC wires attached to the fuel level gauge are not properly insulated, so possibility of a spark igniting fuel vapors exists.

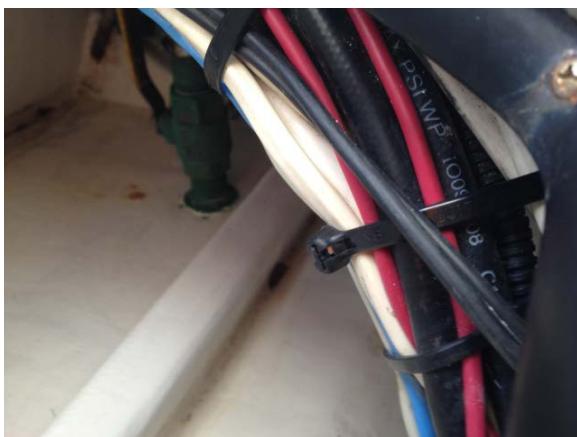
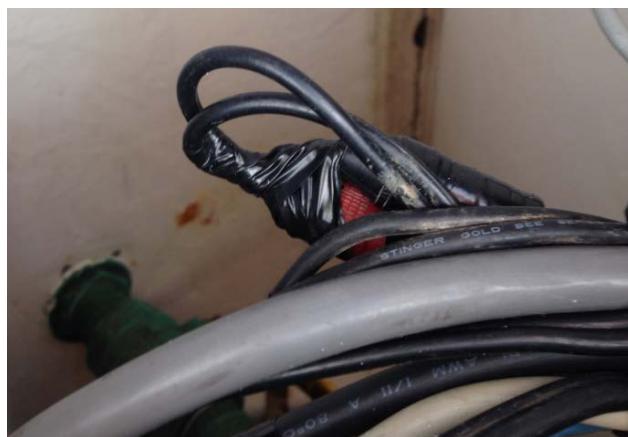
[SEE COMMENT \(19\).](#)

CONDUCTORS: All conductors are wrapped in a single bundle, including DC conductors together with AC conductors and even battery to starting motor cables in the same bundle, all of which represents severe violations of several standards. Several wires are spliced together with non waterproof, electrician's tape.

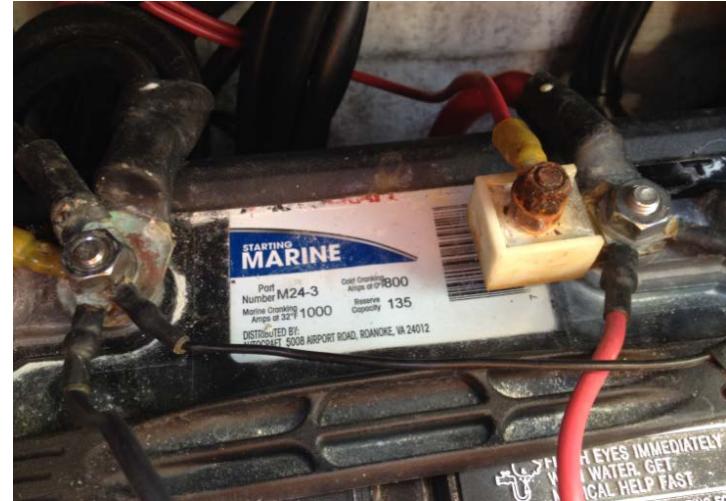
[SEE COMMENT \(20\).](#)

BATTERIES: There are three 12VDC batteries, all of them lead acid wet cells. They are adequately secured but the trays are not acid spill resistant. Also, there is corrosion on the connectors of several cables attached to the battery terminals and the insulation on some of the connectors reveals the stranded copper wire underneath, failing to protect it from possible shorting. All three batteries show a charge level in the 11.0 to 11.5 Volts, far below the 12.5 to 13 + Volt optimal range. This is likely due to the lack of regular charging as charger is not connected to AC source. In this surveyor's opinion, all three batteries are well past their mid life point and will likely start exhibiting failure signs within months.

- 20.** Clean all battery connectors from corrosion. Insulate batteries' positive terminals. Charge batteries regularly including maintenance cycles to keep charge at optimal levels.
- 23.** Replace all hoses and clamps in the potable water system. Alternatively, disconnect the fresh water pump and empty all lines until hoses can be replaced, but refrain from using potable water system in current condition.
- 24.** Replace all hoses and clamps servicing the toilet as well as fixtures such as y-valve used in the plumbing, or alternatively mark the toilet as "Not in Service".
- 26.** Replace all hoses, clamps and fixtures plumbed to the macerator pump, or alternatively, disconnect the pump and discontinue use of overboard discharge system.

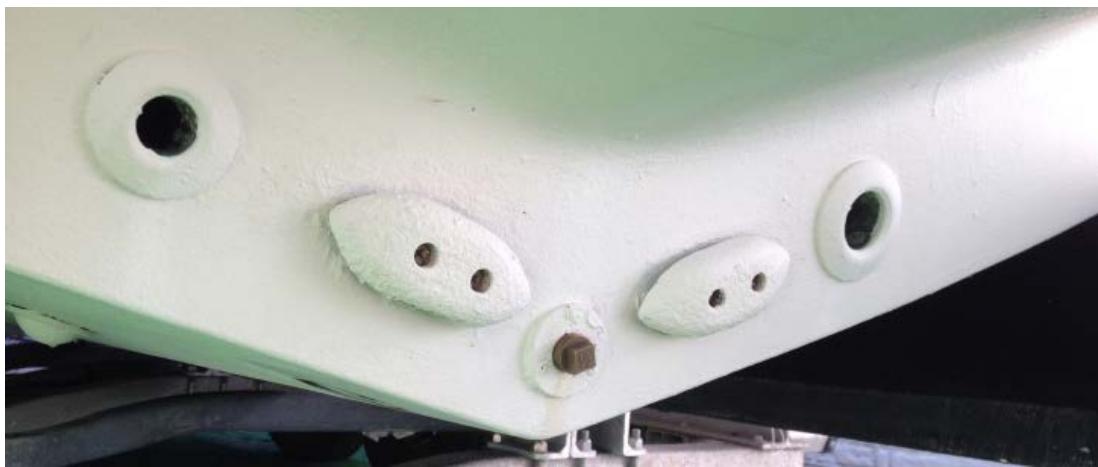
[SEE COMMENT \(21\).](#)

ANODES: Anodes on the stern and on the engine lower units. All appear in good condition but their sufficiency cannot be determined as boat is kept out of water and proper cathodic measurements cannot be undertaken. The two anodes on the stern are painted over, rendering them useless.

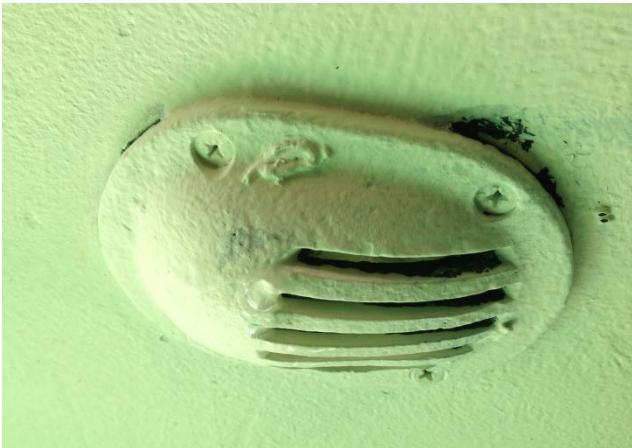
[SEE COMMENT \(22\).](#)

BONDING: The underwater metal components do not appear bonded and all metal through hull connections have also been painted over, decreasing their capacity to carry stray currents and their anti corrosive capabilities.

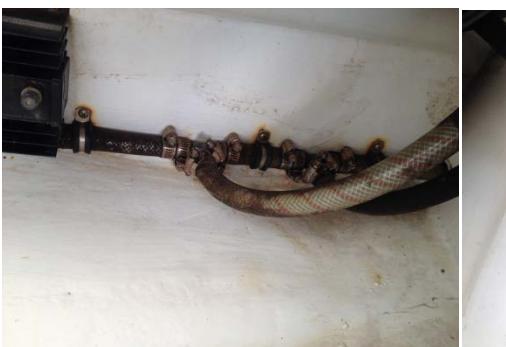
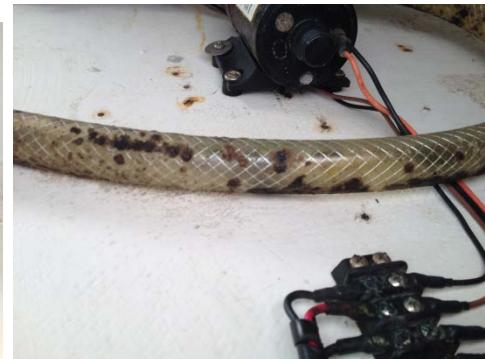
[SEE COMMENT \(23\).](#)

POTABLE WATER: Potable water tank is contained near the transom, encased by a bulkhead and frames, making estimation of size difficult, but appears in the 20-30 gallon range. Tank was empty verifying the system function was impossible. A fresh water pump was heard to prime when activated. However, all hoses used in the potable water system are in near-failure condition and they are run in the same compartment as the macerator pump and open electrical wiring connections.

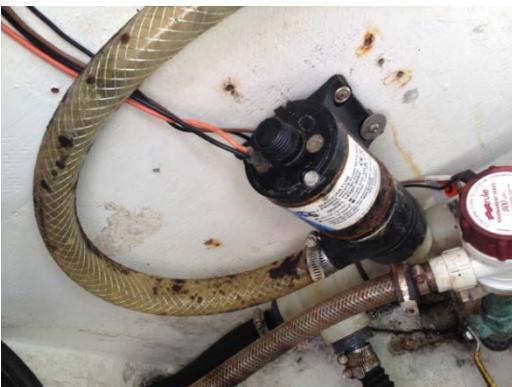
[SEE COMMENT \(26\).](#)

WASTE PUMP-OUT/OVERBOARD DISCHARGE: A macerator pump is installed near the transom bulkhead, the hose that presumably comes from the black water tank is at near-failure point and some waste permeation is apparent. Macerator pump also exhibits signs of rust that has eaten away at its case. The pump out end has been plumbed in an arrangement where it shares a sea cock with other dumps, an extremely unsanitary condition and standards violation.

25. Replace all hoses, clamps and fixtures plumbed to the black water tank. Clean and sanitize area if waste permeation has occurred.
26. Plumb macerator pump to a single overboard discharge.

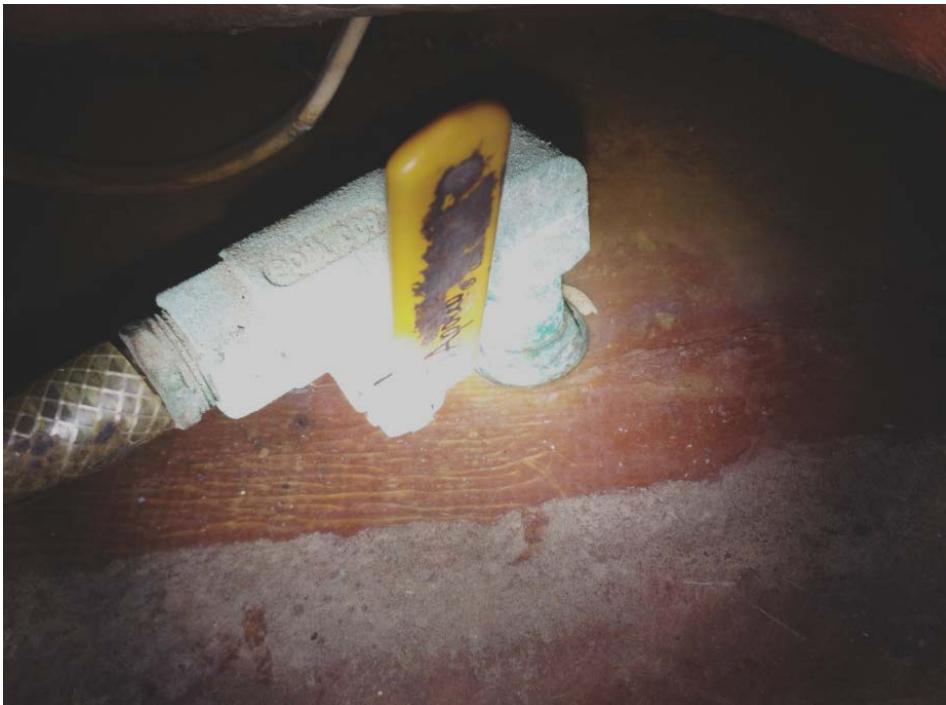
[SEE COMMENT \(28\).](#)

Likely due to the lack of a backing plate, the through hull ring has embedded itself into the fiberglass hull and loosened the device to the point where it can be freely moved by hand. This has caused the fiberglass around to crack and possibly delaminate, and water oozes from the seal every time the sea cock is moved, evidence of water penetration and saturation in that area. Taking into account the fact this boat is dry and has been on land for a predictably long time, the presence of water in the hull speaks to the seriousness of this issue. Moisture readings on the hull side are all in the Saturation level as expected. This device is at risk of completely coming lose with the subsequent water ingress into the boat and likely sinking of the vessel. Surveyor STRONGLY advises the vessel not be put in the water until this issue has been dealt with.

28. **IMMEDIATELY** remove this sea cock from hull and repair associated damage. This repair should only be undertaken by a professional. When, or if, installing a replacement sea cock, utilize a suitable backing plate and double clamp all hoses. It is strongly advised vessel not be put in the water until this issue has been solved.

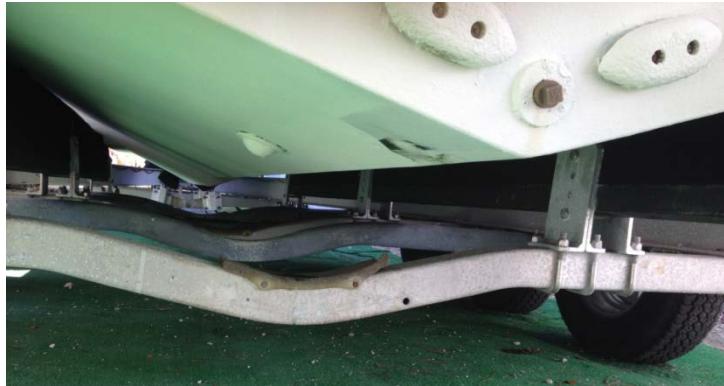
However, it is the opinion of this surveyor that this type of trailer as it is configured right now is not suitable to hold this vessel. Although load capacities are assumed to match and trailer frames and wheels seem to be in good working order, the rafters are not positioned in a way that hold the weight of the vessel mostly at the keel, the area of heaviest load distribution. The keel of the vessel is in fact free floating as can be seen in the photo and all weight is supported under the running strakes. Also, this hull is of stepped construction which basically reduces the width of the strakes where the stepping occurs, and rafters are pushed against the wider portion of the hull at an uneven angle, leaving a large part suspended in the air and only supported by a contact area of approximately one square inch on each side. The above set up is not conducive to holding the vessel in a manner that prolongs its life, as it places undue stress on parts of the hull not ideally suited for such, and may damage the hull in the near future or have already done so.
